# FAQ's for Campaign 51101-C

# Workhorse Campaign 51101-C

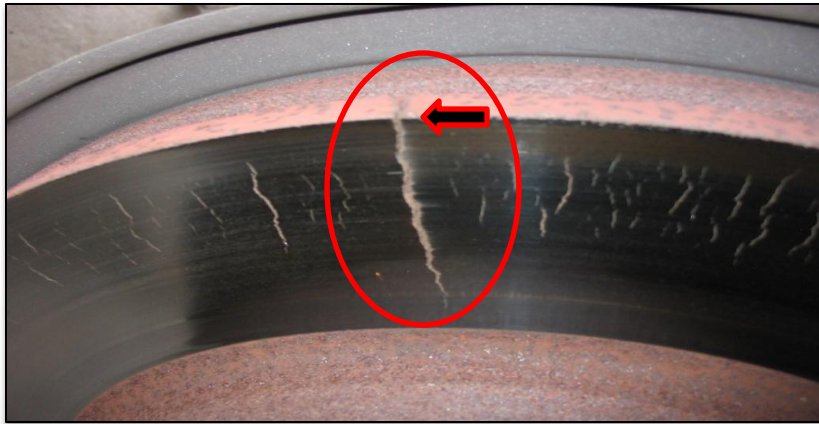
Radial crack into cooling fin w/o transfer-Non warrantable

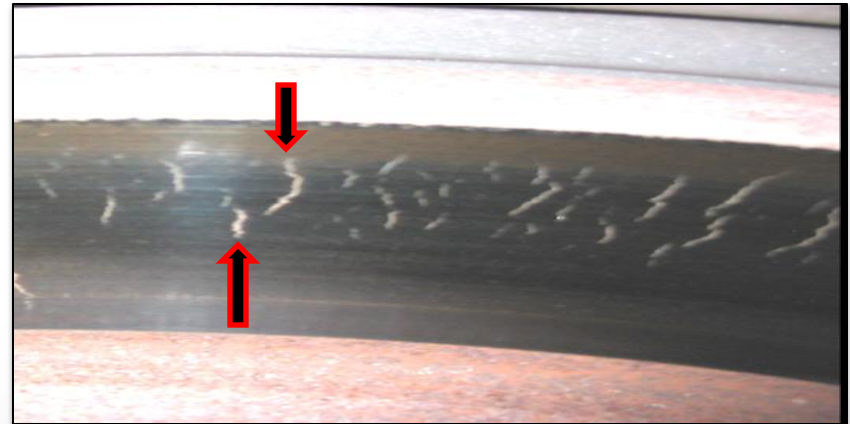
"Heat Checking"-Normal Condition, Non warrantable

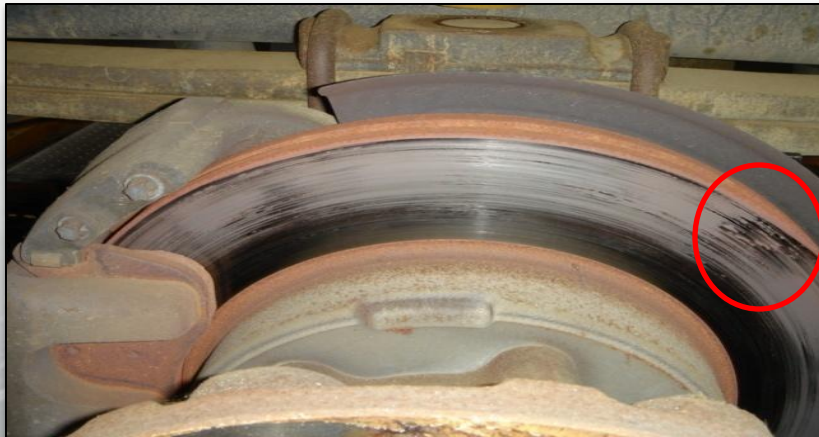
Heavy transfer on 2 sides of rotor, face missing material. Warrantable-covered as collateral damage from caliper

- Workhorse will evaluate cases on an individual basis where the brake caliper assembly is believed to have caused collateral damage to another brake system component. If the brake caliper is found to be the root cause of another brake system component failure, the affected component may be covered by Workhorse.

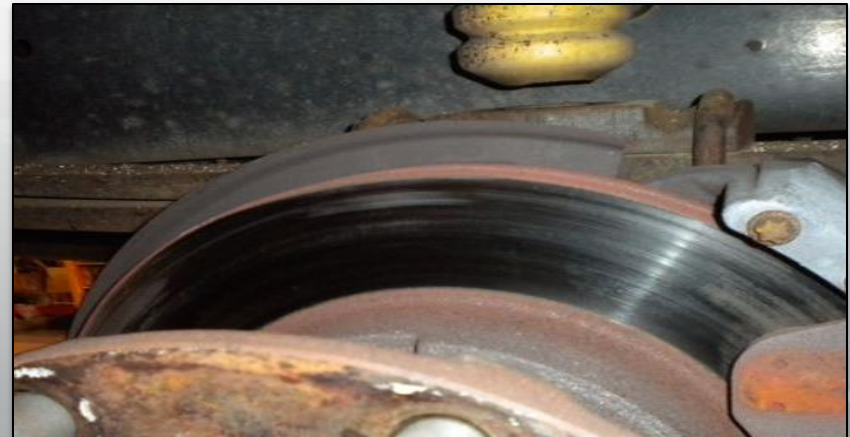
Light pad transfer on face of rotor-Normal Condition-no replacement needed

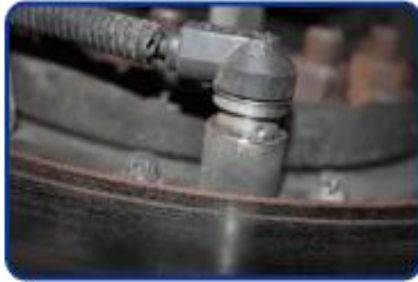
A properly functioning ABS speed sensor

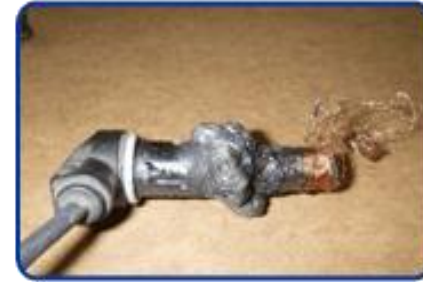
A heat damaged ABS speed sensor

- An illuminated ABS lamp may indicate an active ABS system fault, which will require retrieving diagnostic trouble code(s). If DTCs 21, 25, 31, or 35 are active, the speed sensor(s) failure is most likely related to heat damage caused by a caliper failure and may be replaced as part of Campaign 51101-C.
- An ABS sensor which has been heat damaged may appear melted but there are some circumstances where a sensor can have low resistance or be internally open without showing extreme signs of heat on the outside.
- If the ABS light is on and the diagnostic trouble code(s) in the module is not one of the above listed DTCs, the failure is not related to Campaign 51101-C and will need to be repaired at the owner's expense.

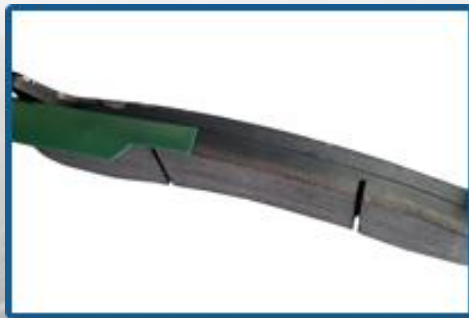
Good (12mm)

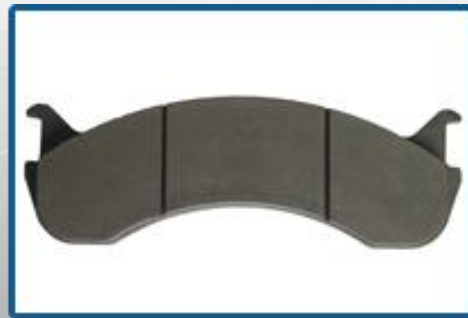
Pad-New

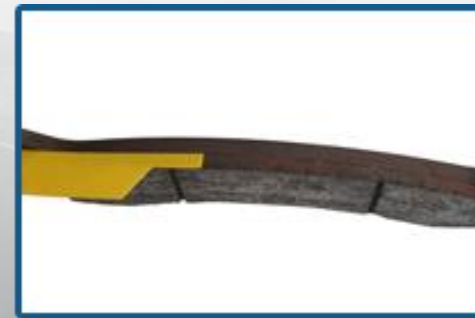
Bad (6mm)

Brake pads are considered wearable items on all vehicles and can have their useable life affected by many factors; including, but not limited to: driving habits, type of traffic driven in, geographical location and vehicle weight. Campaign 51101-C does not cover brake pads, as these are part of RV chassis maintenance.
